Audubon Southwest: Horseshoe Reservoir Habitat Restoration Study

OPPORTUNITIES FOR ESTABLISHING NATIVE BOTTOMLAND HABITAT IN HORSESHOE RESERVOIR

Study supported by Salt River Project and The Nature Conservancy

Tice Supplee and Mark Briggs
March 12, 2024

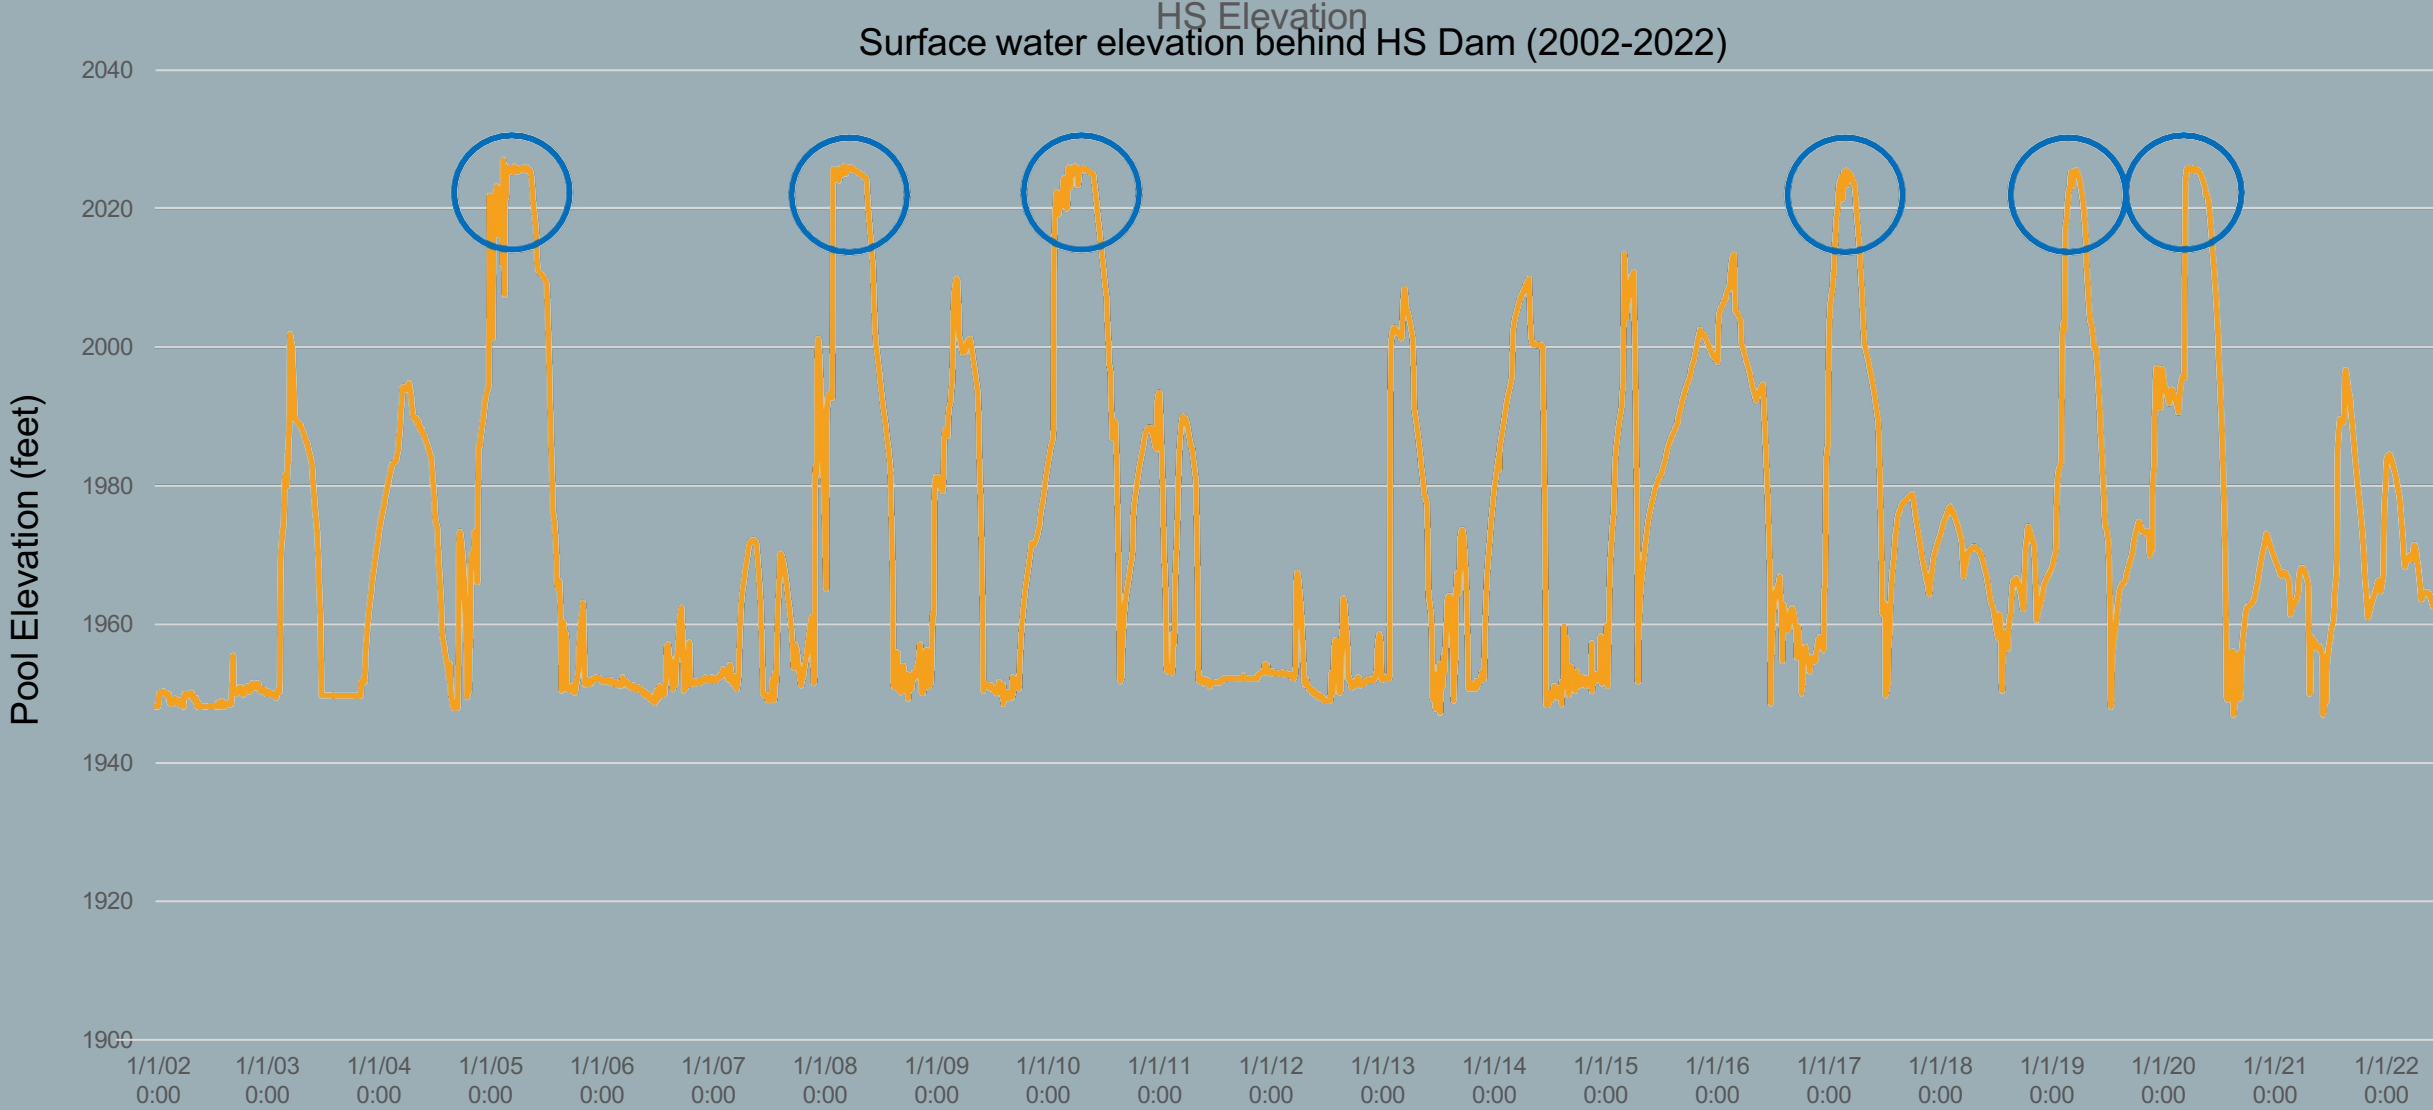
Conservation Pool Frequency and Duration

Data courtesy of SRP

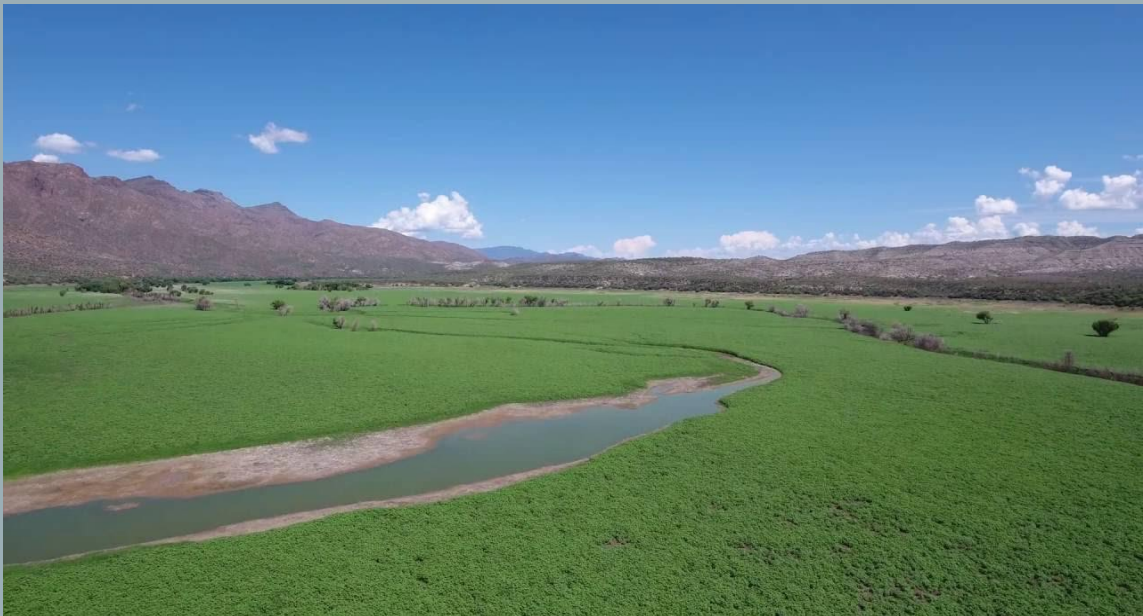
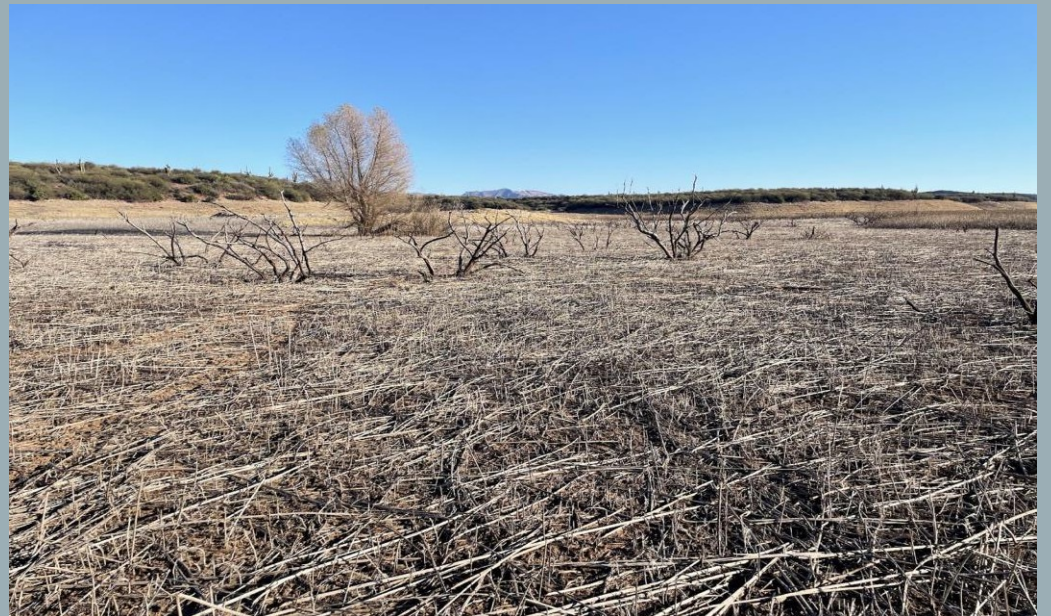
Natural Alluvial River Bottomland Environment

Non-obligate Riparian Zone

Prosopis spp., *Celtis* spp.,
Chilopsis linearis, *Acacia* spp.

Obligate Riparian Zone

Salix spp., *Populus fremontii*.,
Juglans major, *Fraxinus*
velutina

Emergent Wetland Zone

Typha spp., *Carex* spp. ,
Scirpus spp., *Juncus* spp.

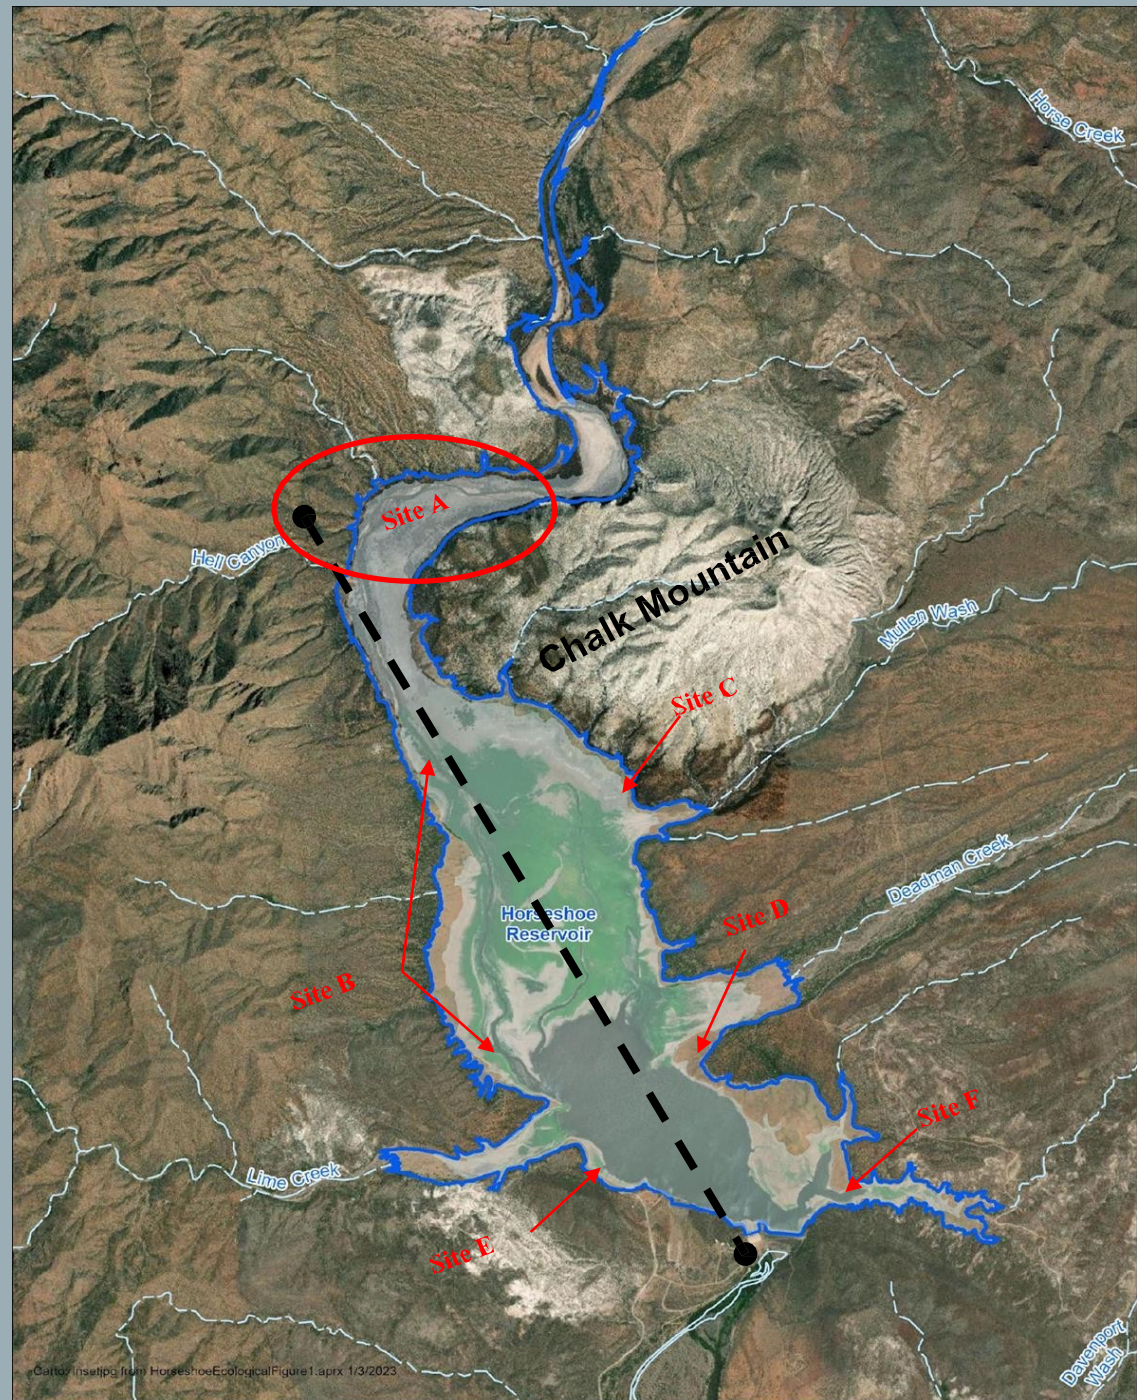
Restoration Site A

(image provided by SRP Cartographic & GIS Services).

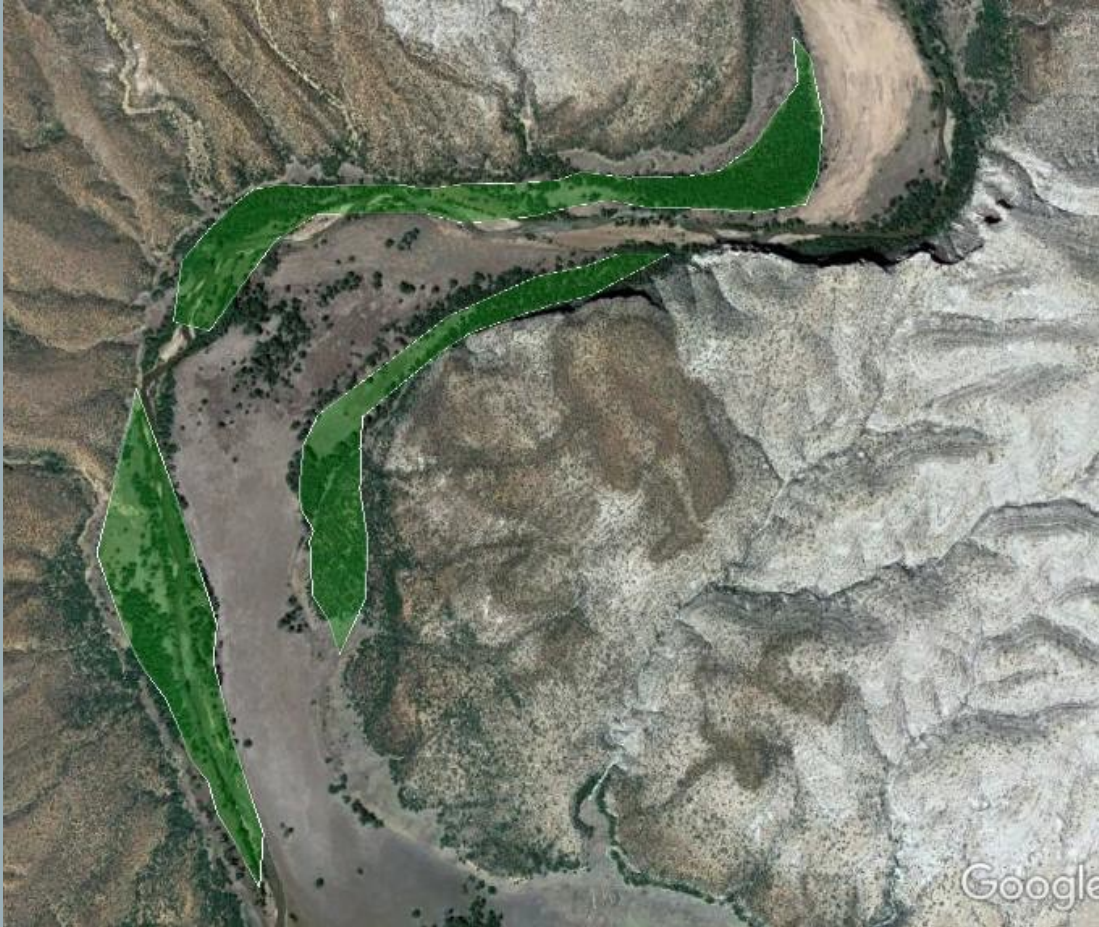
Restoration Site A

- Furthest upstream
- Dynamic natural hydrology (less impacted by dam impoundment)
- Inundated 9.1% of time between 2002 and 2022
- Frequency and duration of inundation likely much reduced under run-of-river management
- Natural process dominate and likely to be strengthened in future under run-of-river management

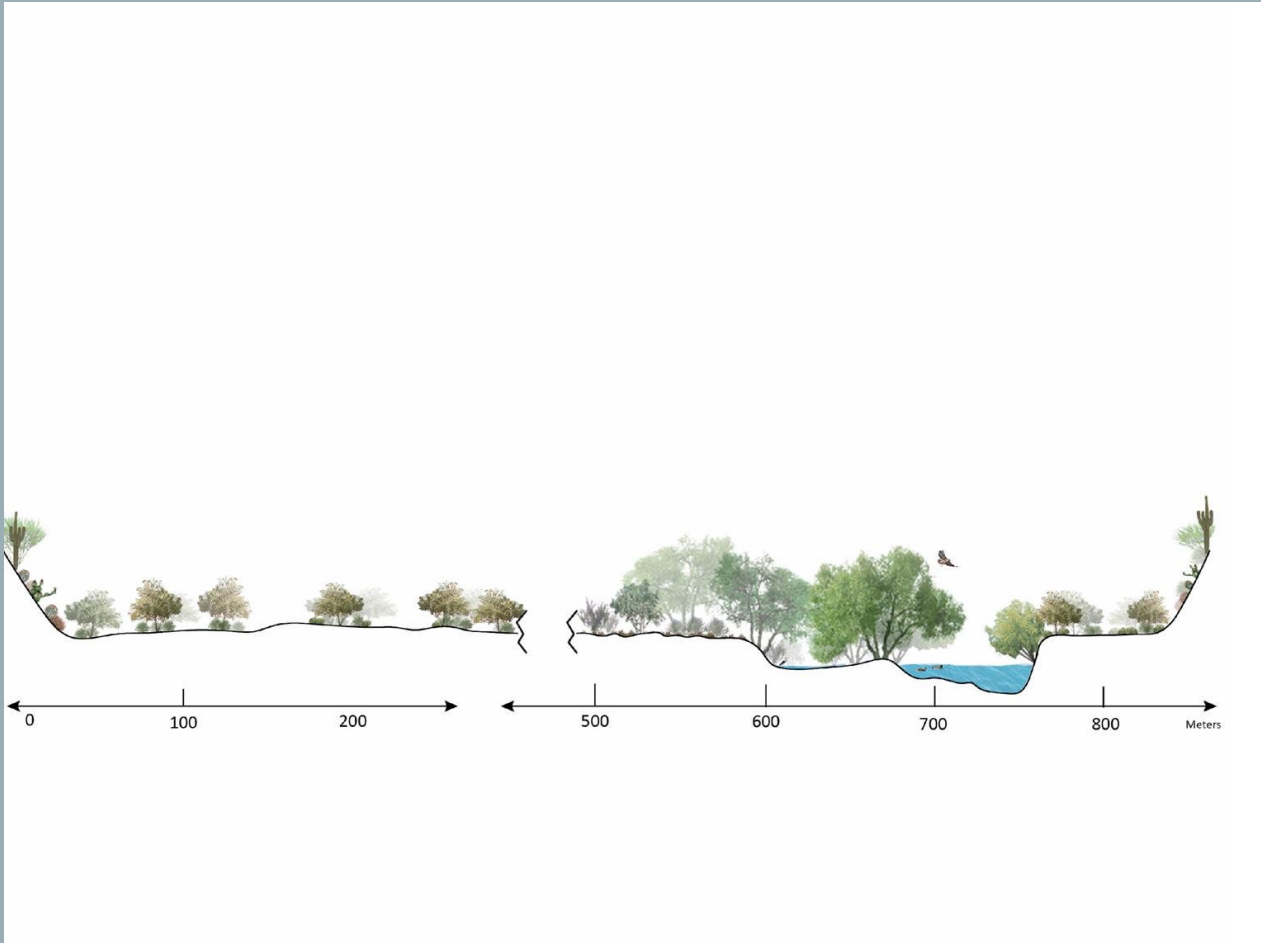
Restoration Site A

Digital Rendering of Restoration Objective at Site A (by Teresa Rene DeKoker)

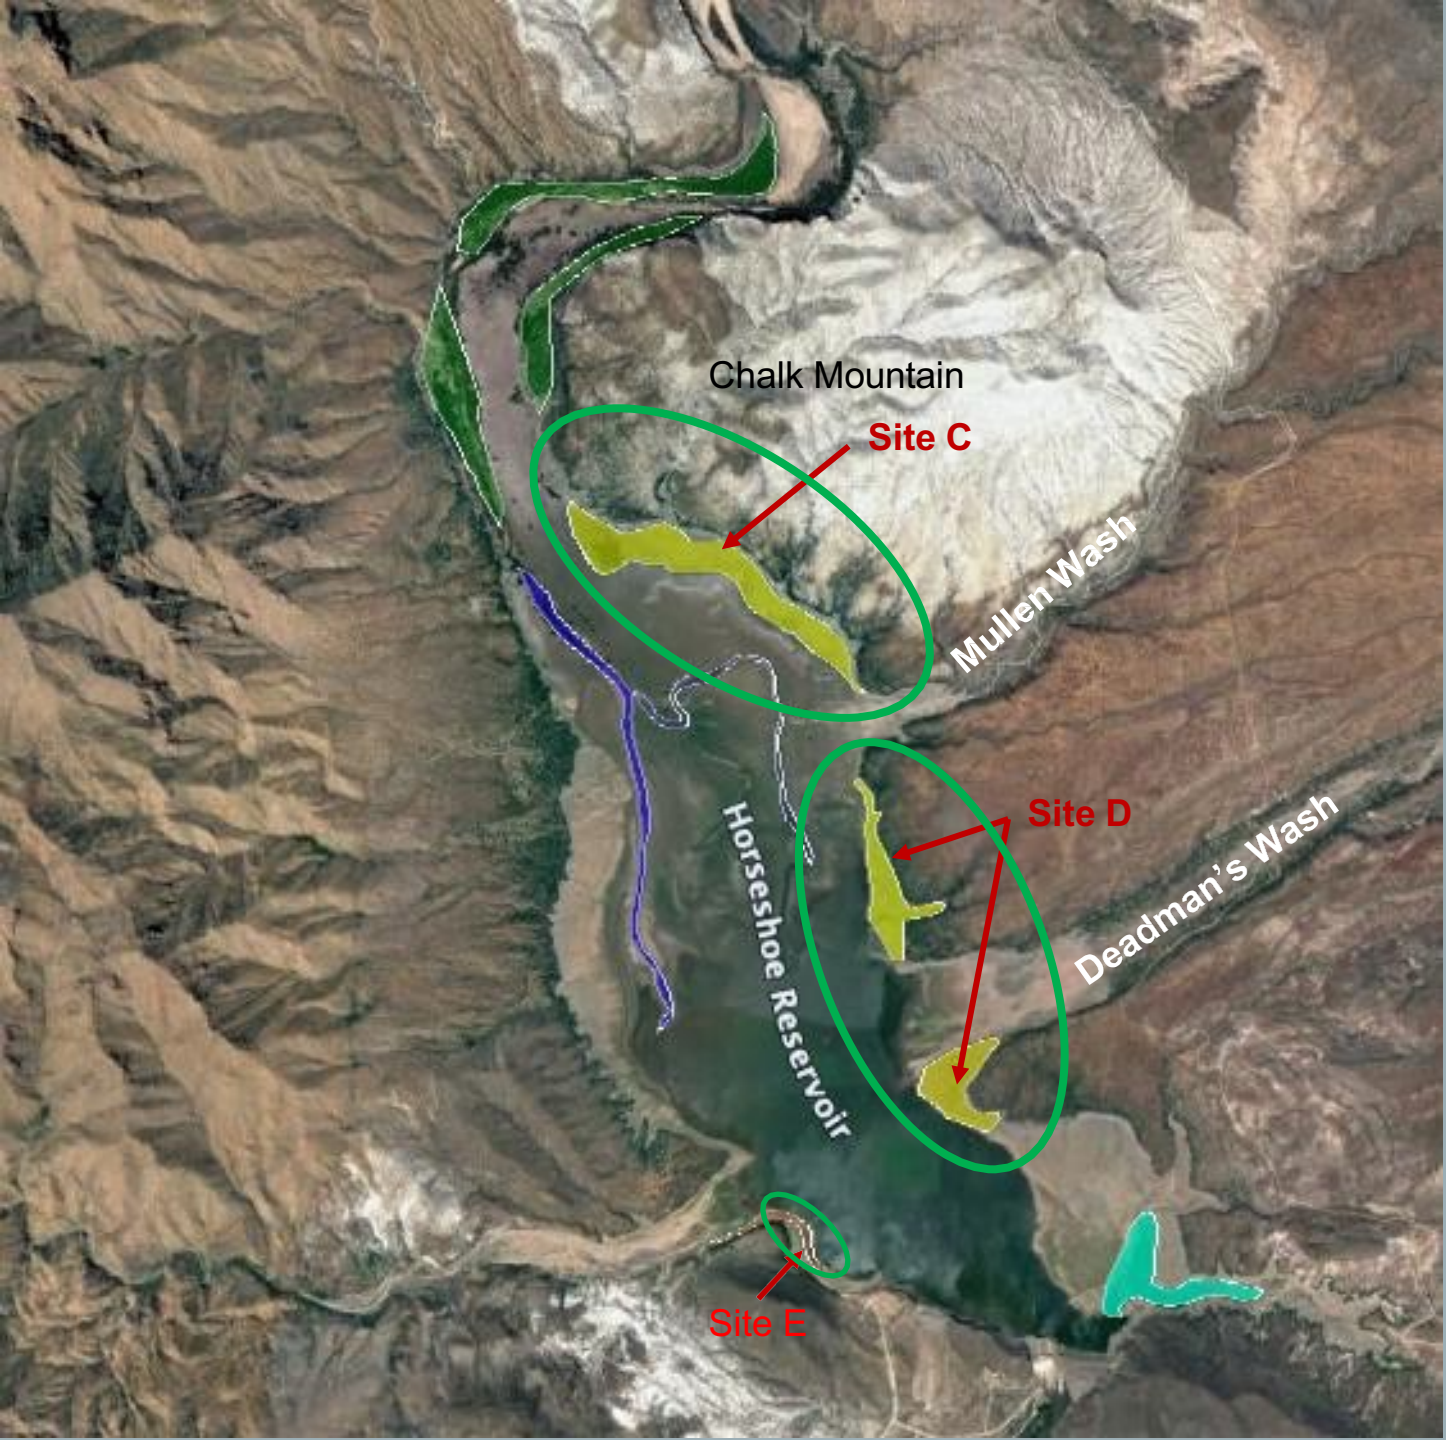
Restoration Sites C & D & E

- On east shore of reservoir at confluence with Mullen Wash and Deadman's Wash
- E located below the boat ramp northwest of the dam
- Relatively large floodplain surfaces between 2,007 ft to 2,012 ft elevation
- Inundated over 12% of time between 2002 and 2022
- Locations appear highly protected from flood scour
- Under run-of-river management will presumably be inundated less

Daily surface elevation data of Horseshoe Reservoir pool from 2001 to 2021 indicate that the majority of the surfaces that comprise Restoration Sites C and D were underwater 12% of the time

Given reduced frequency and duration of inundation of Site C and D surfaces, native bottomland vegetation (mostly non-obligate riparian species) of Mullen and Deadman's Wash likely to spur native plant establishment

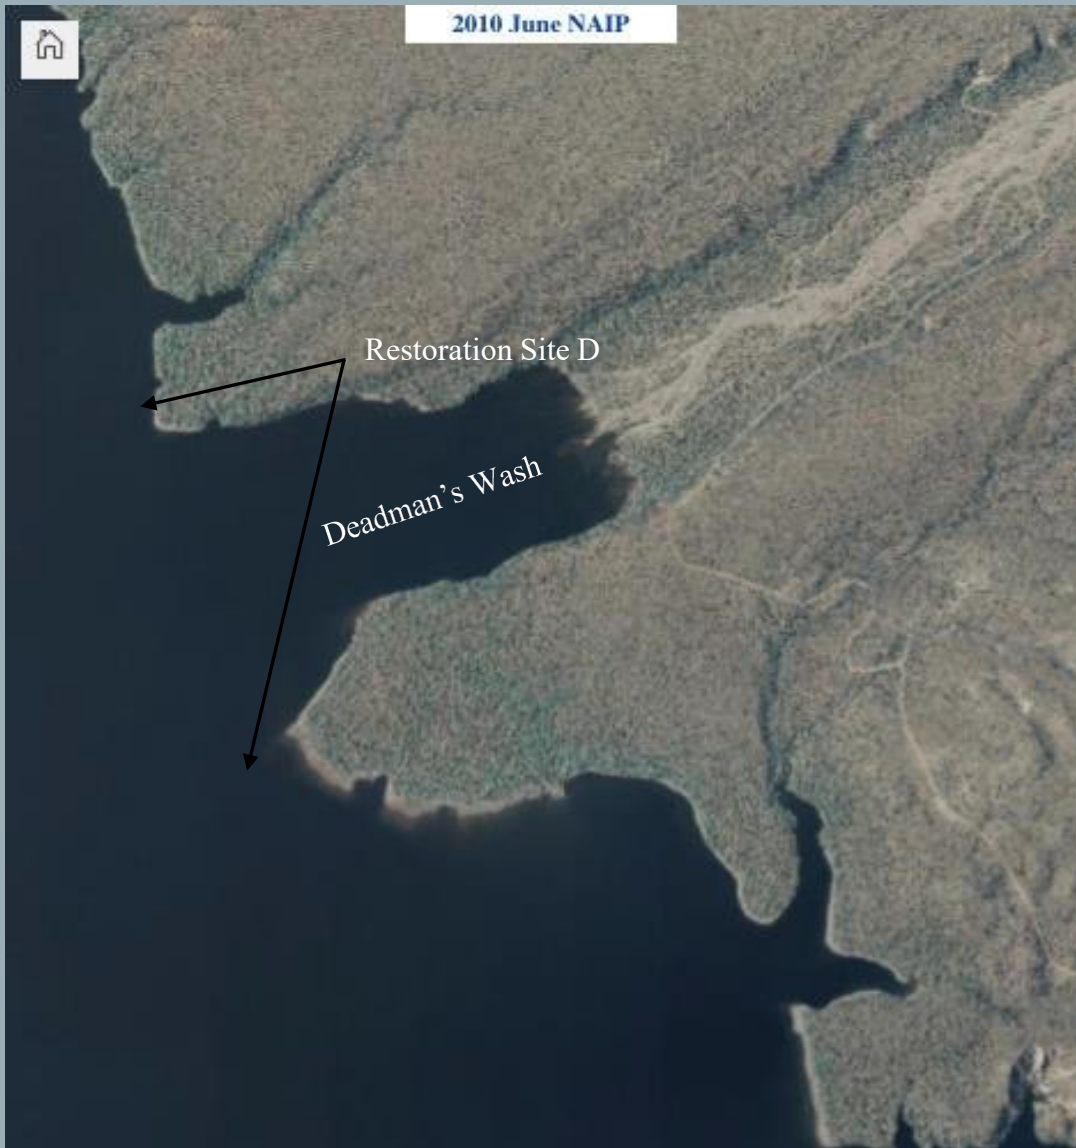
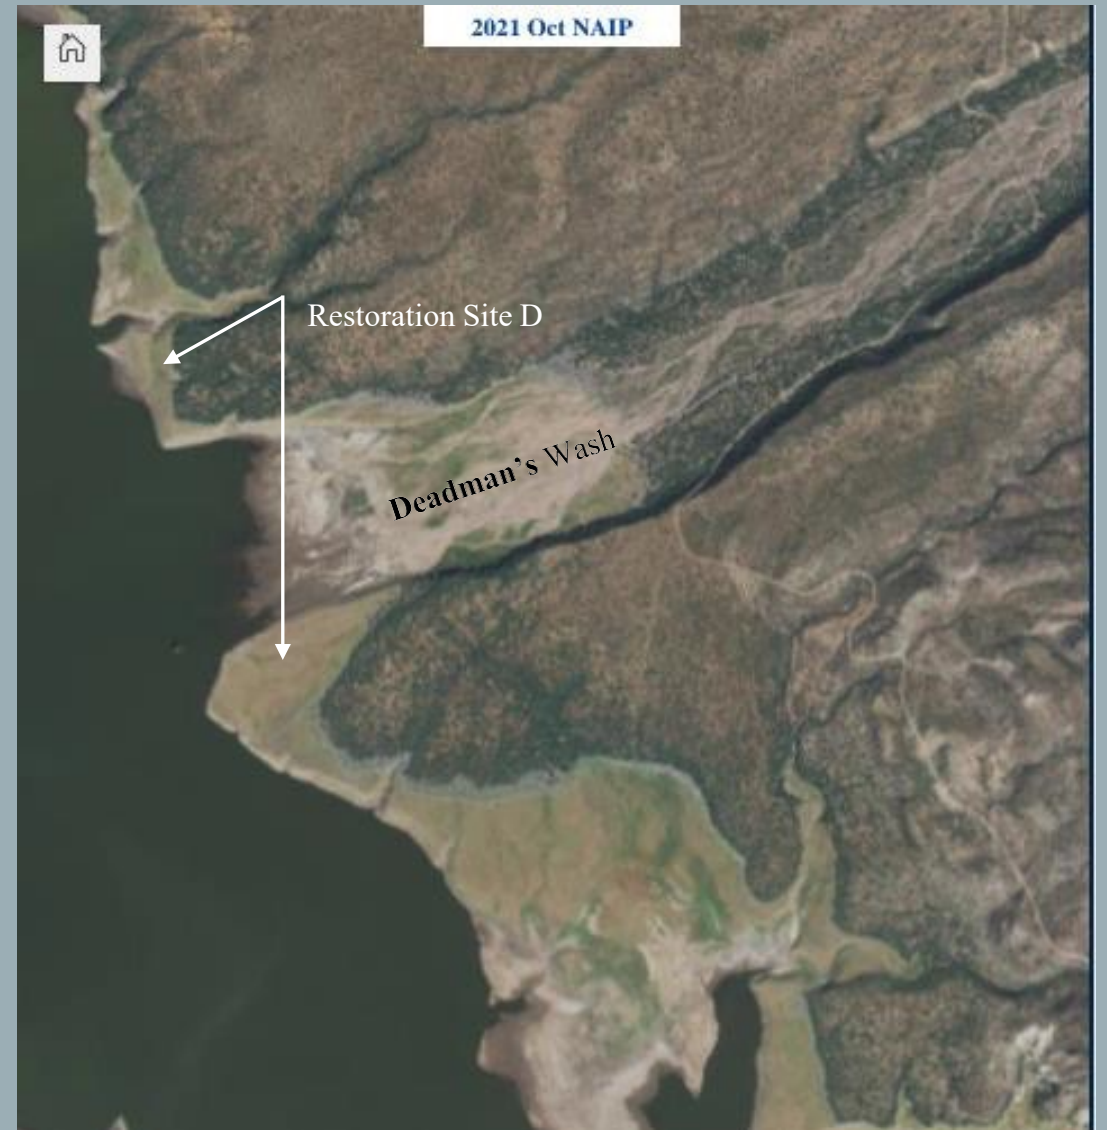
Thanks to Jen Wennerlund and Matt Russo (Cartographic and GIS Services, SRP) for direct image comparison viewer

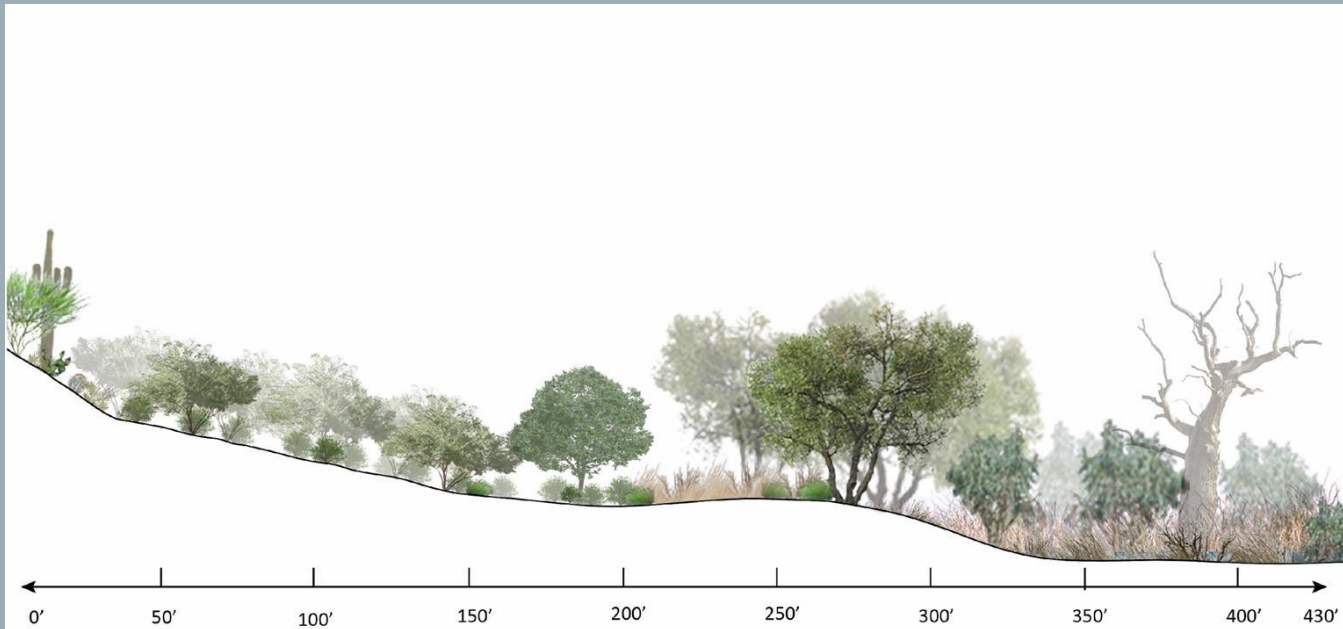
Restoration Sites C & D & E

Digital Rendering of Restoration Objective at Site C (by Teresa Rene DeKoker)

- Broad floodplain surfaces that under run-of-river management will presumably be inundated less frequently
- Potential for natural regeneration due to native bottomland seed sources in associated washes (non-obligate riparian)
- Some topographic diversity = diverse native bottomland plant establishment (via natural and artificial means)

Cons:

- Potential low water availability could negate obligate riparian
- Changes in soil chemical and physical characteristics impede natural recruitment

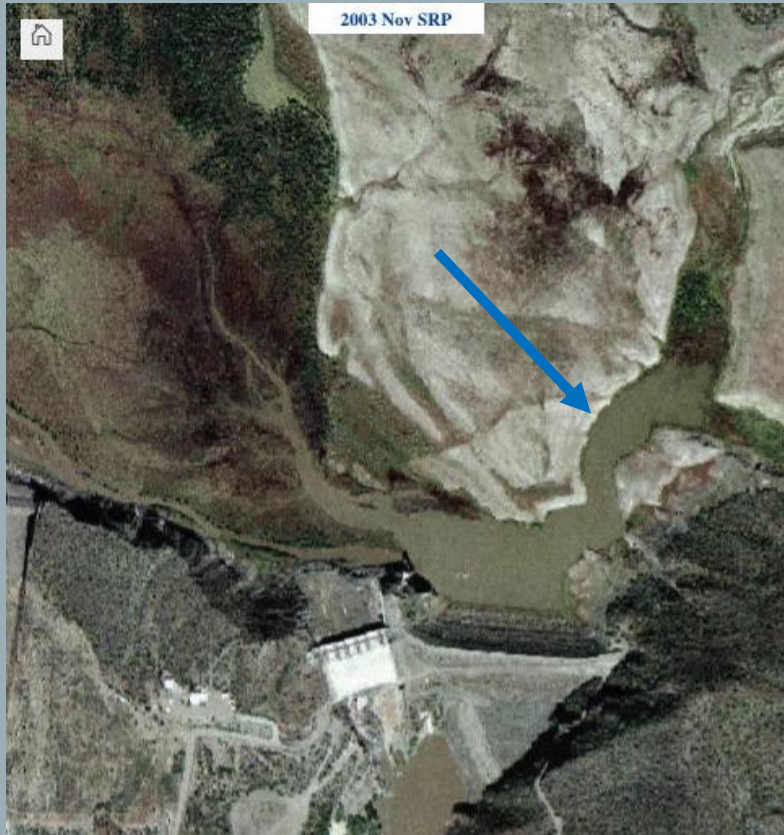
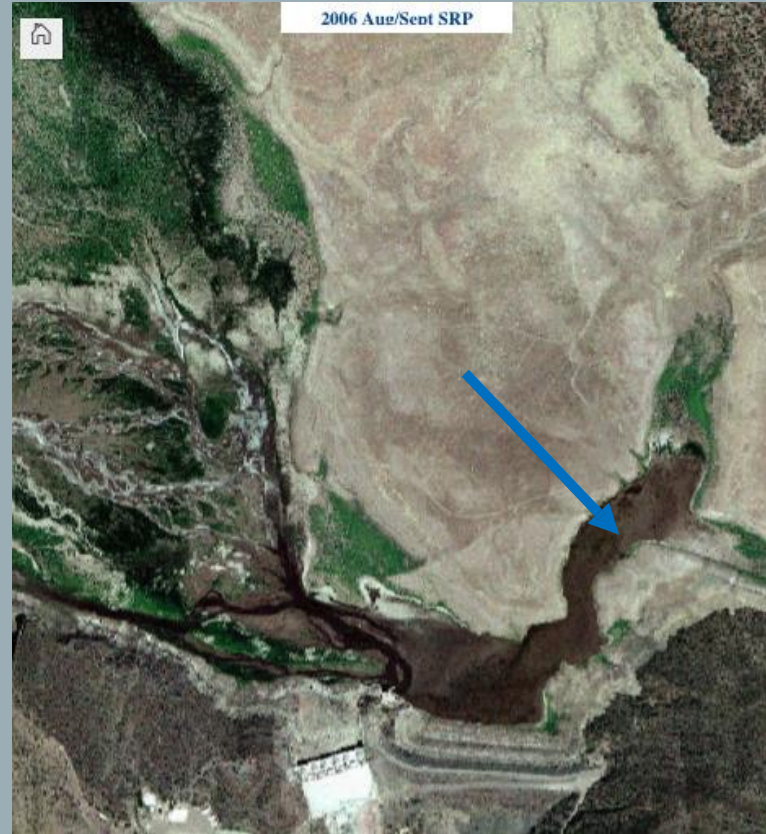
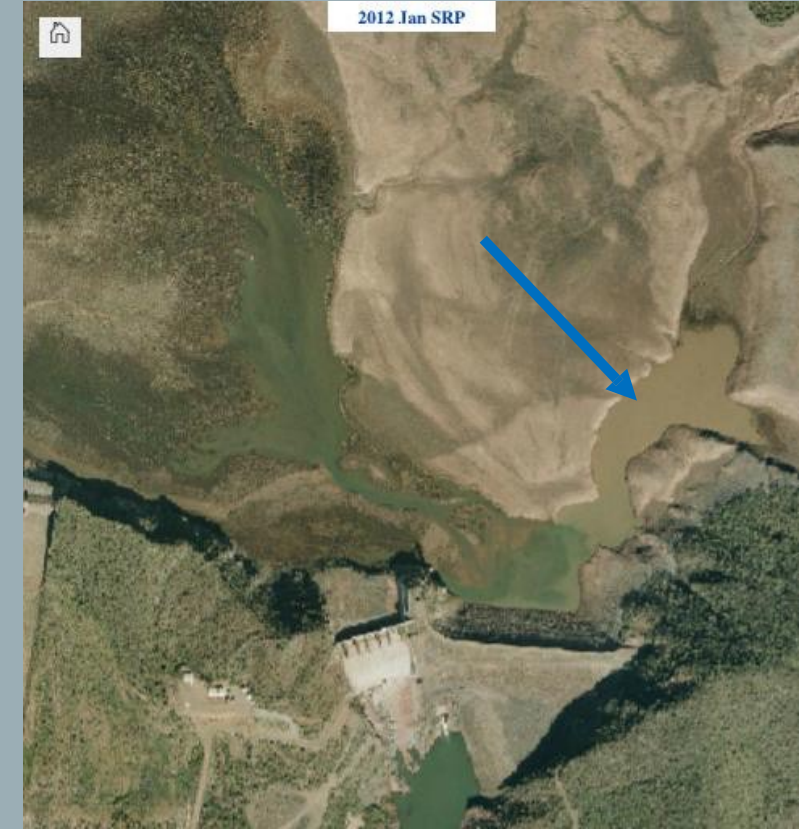
Majority of the lower elevated surfaces that comprise Restoration Site F were inundated over 96% of the time during the 2001 – 2021 period

Thanks to Jen Wennerlund and Matt Russo (Cartographic and GIS Services, SRP) for direct image comparison viewer

Of all the Proposed Restoration Sites, Restoration Site F may have Conditions Most Suitable for the Establishment of Non-Obligate Riparian, Obligate Riparian, and Emergent Wetland

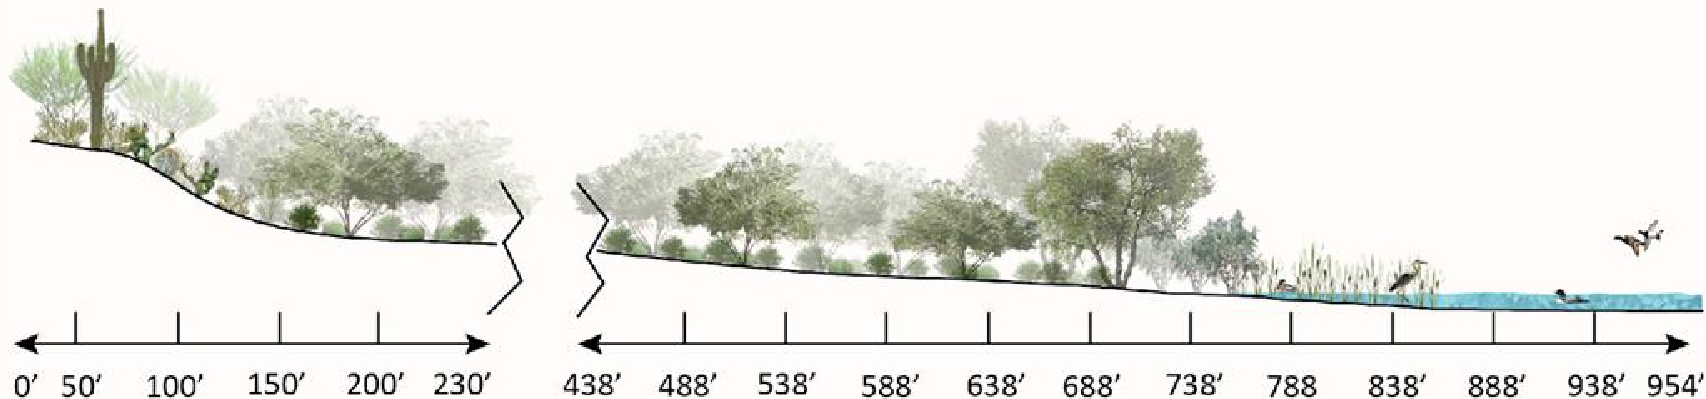
← Water Availability and Flood Disturbance →

400' 430'

Digital Rendering of Restoration Objective at Site F (by Teresa Rene DeKoker)

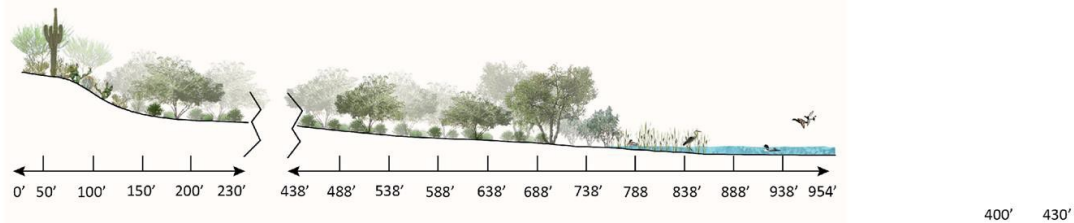
Restoration Site F

Digital Rendering of Restoration Objective at Site F (by Teresa Rene DeKoker)

Pros:

- Inlet backwater site that could hold water (or at least have higher water availability) during dry, hot periods
- Topographic diversity = diverse native bottomland plant establishment (via natural and artificial means)
- Potential opportunity to complement vegetation restoration with efforts to improve habitat for razorback sucker and other native fish
