## Restoring Little Green Valley Wet Meadow 2024-2026

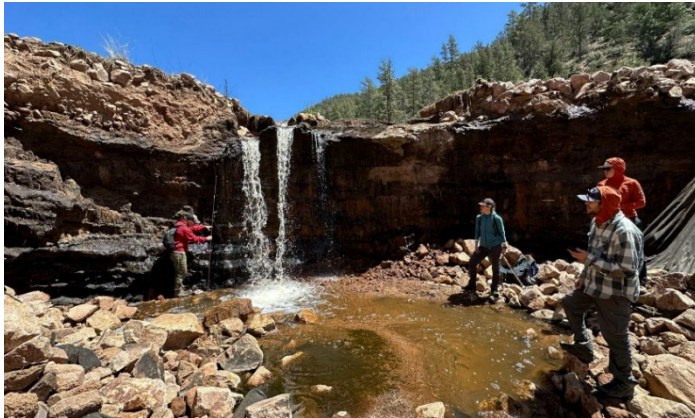
Figure 1: Most significant headcut in 2024 prior to restoration.

Decades of headcutting and erosion channelized and dried large portions of the Little Green Valley wet meadow and threatened the entire wetland complex. Little Green Valley is a recommended Botanical Area in the Tonto National Forest (TNF) plan with the purpose of enhancing and protecting unique soil conditions and plant communities. Degradation of the system came from an upstream, in-channel material borrow pit and an over 15-foot headcut at the bottom of the wet meadow. (Figure 1)

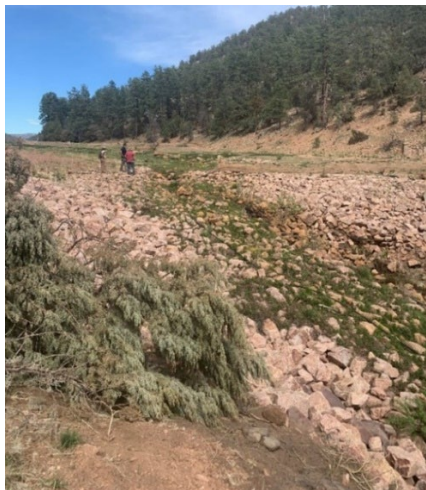
Throughout the wet meadow system on public and private land, downcutting ranged from 1 foot to over 10 feet, with the most significant degradation on National Forest System (NFS) lands. The 15-foot headcut was first arrested using riprap in 2011, (Figure 2) however, the system continued to degrade and in 2023 the riprap failed and the headcut began advancing into the wet meadow again. (Figure 3)

Figure 2: First headcut repair in 2011.  
(Shown here 10 yrs after initial repair in 2022)

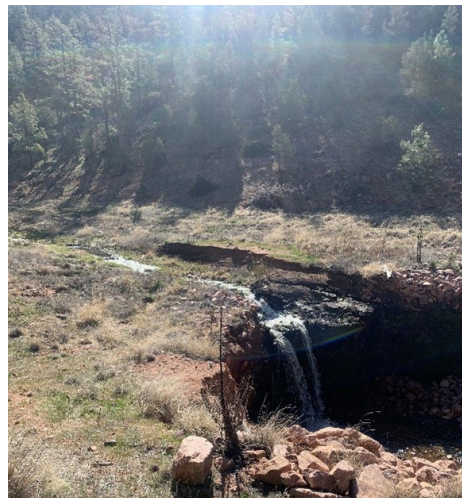
Figure 3: In 2023 after the repair failed.

The goal of the 2024 Little Green Valley Wet Meadow Project was to stop the headcut from advancing, restore wet meadow hydrology, and increase the system's resilience to drought, wildfire, and flood. The project used a Stage 0 approach, whereby the entire valley floor is reset by cutting and filling areas based on if they are above (cut) or below (fill) the target elevation. This target elevation is determined by using a relative elevation model and the geomorphic grade line.<sup>1</sup> (Figure 4) While dozens of Stage 0 projects have been completed in wet and dry environments in the Pacific Northwest and Colorado, the Little Green Valley Wet Meadow Project was the first Stage 0 project in the Southwest.

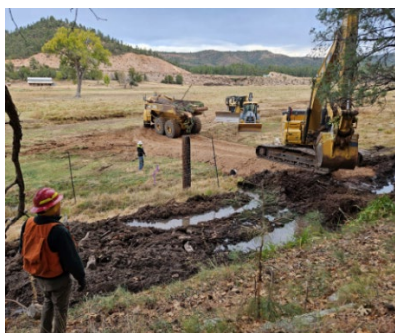
Figure 5: Building the access road

All trees, plants, and fill material were sourced onsite, and sedge, rush, and grass seed was collected at the wet meadow by seed collection crews in summer of 2024. Phase 1 included building an access road (Figure 5), bringing the headcut and 5 acres below it to grade (Figure 6), and seeding/planting. Between Phases 1 and 2 a new headcut opened at the bottom of the project area (Figure 7) where flow concentrated due to the unrepaired remaining channel upstream and the lack of stabilizing vegetation. Phase 2 repaired this area, filled 4 additional channels, brought an additional 5 acres to grade, and decommissioned the access road.

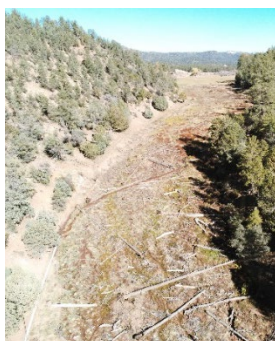
Figure 6: USFS drone footage of Phase 1 taken 12/2025 looking upstream

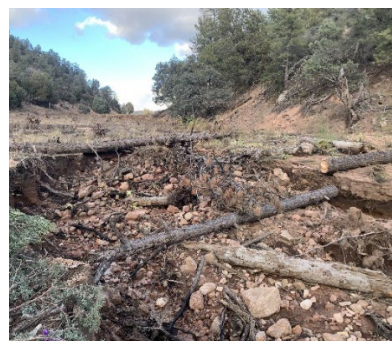
Figure 7: New headcut at bottom repaired in Phase 2

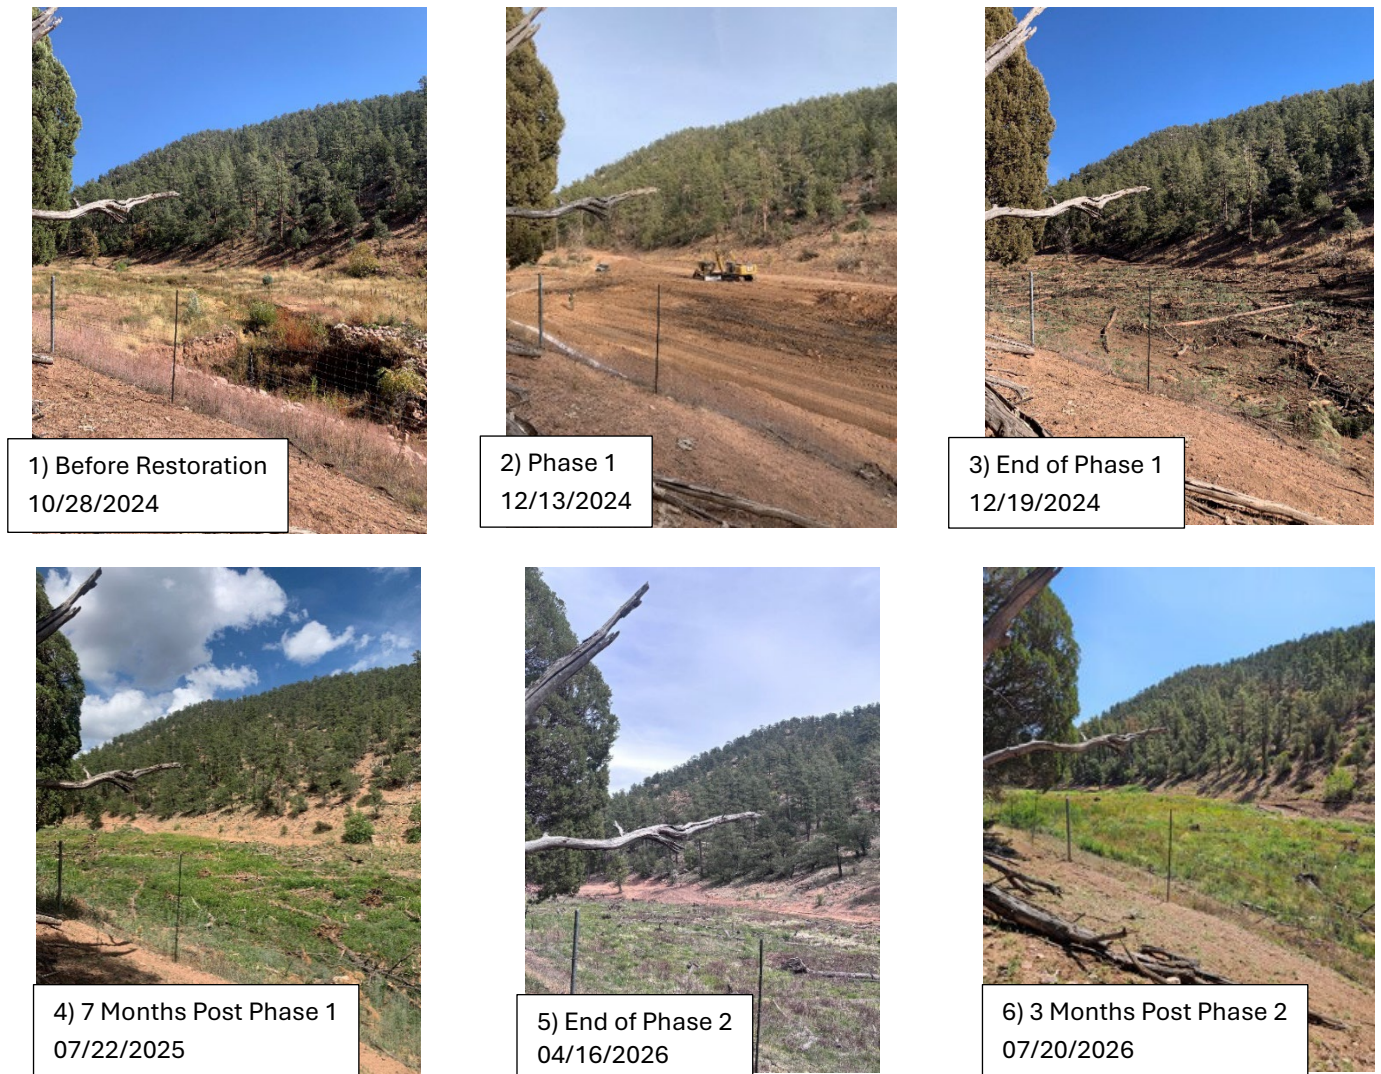
Figure 9: Photo Point 2 - Looking East (Upstream) at the Large Headcut.

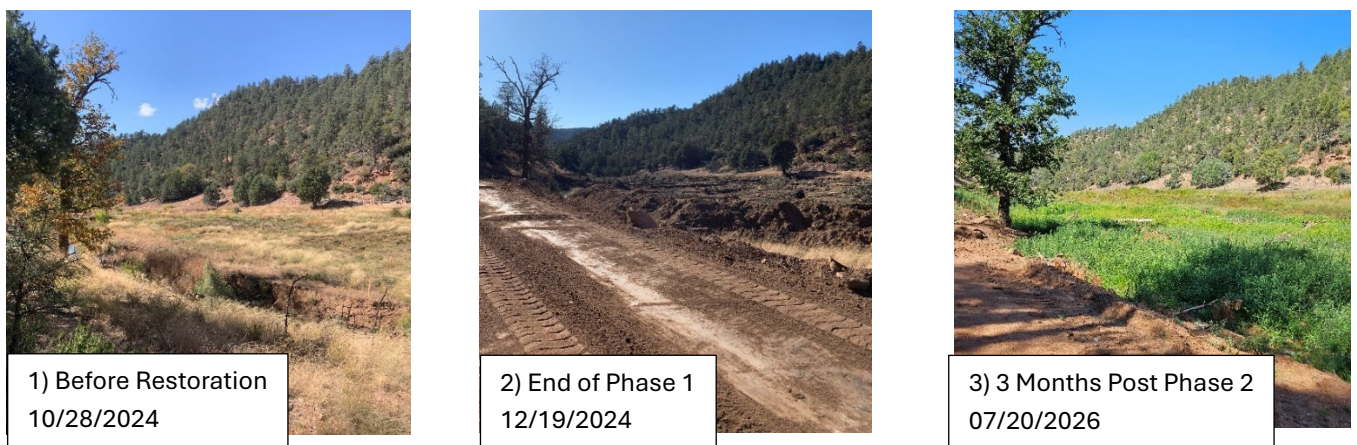
Figure 10: Photo Point 3 - Looking West (Downstream) Midway Through Lower USFS Property.
