USGS science supports bi-national efforts to restore riparian ecosystems in the Colorado River delta in Mexico under two 1944 Water Treaty Minutes (319 and 323)

Pamela Nagler

US Geological Survey, Southwest Biological Science Center

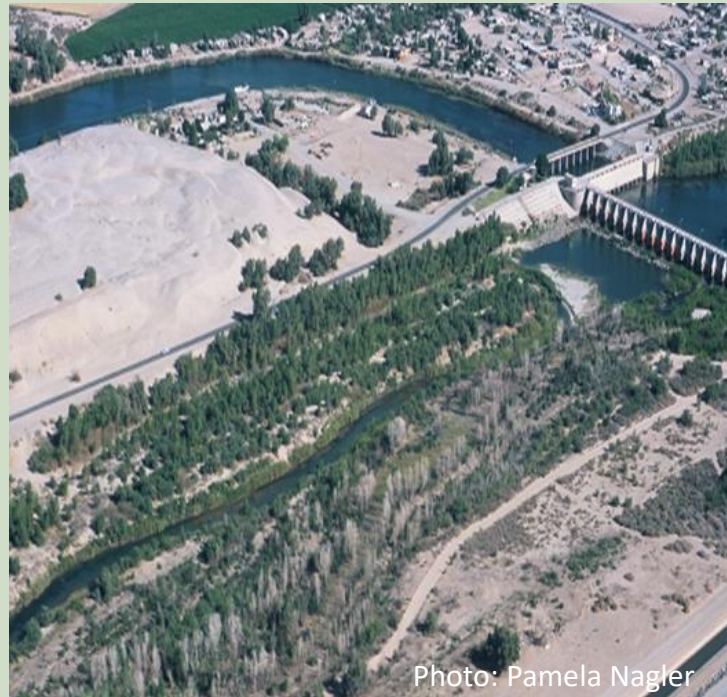
In the Riparian Corridor

Since 2011, the unrestored reaches lost 11% EVI2 (greenness) and 28% ET(EVI2) (-0.73 mm/d), but restored sites increased 36% in EVI2 and 20% in ET(EVI2) (0.58 mm/d).

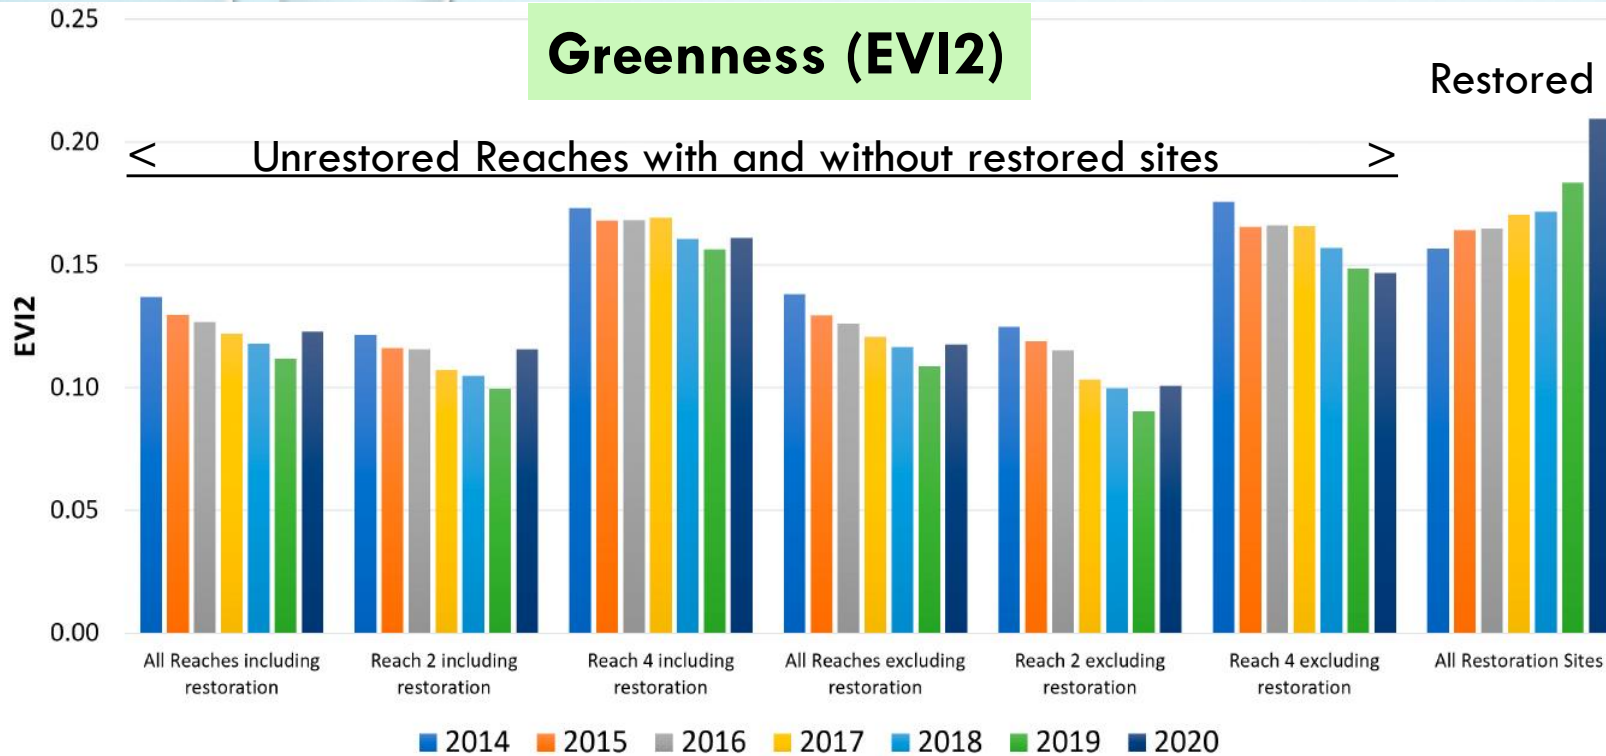
Greenness (EVI2)

Up until 2014, *greenness* decreased at 1.1% /year & ET decreased at 1.4% /year

After 2014, *greenness* decreased by 1.5% /year & ET decreased at 0.9% /year

The restoration areas are markedly greener than the surrounding reach area's unrestored riparian landscape.

A key finding is that over 21-years EVI2 (greenness) in the unrestored corridor decreased by 23.6% and ET(EVI2) decreased by 32% (0.87 mm/day).

Since 2018, Minute 323 water delivered to restored sites increased EVI2 (greenness) by 33.6% and increased ET(EVI2) by 58% (1.29 mm/day).

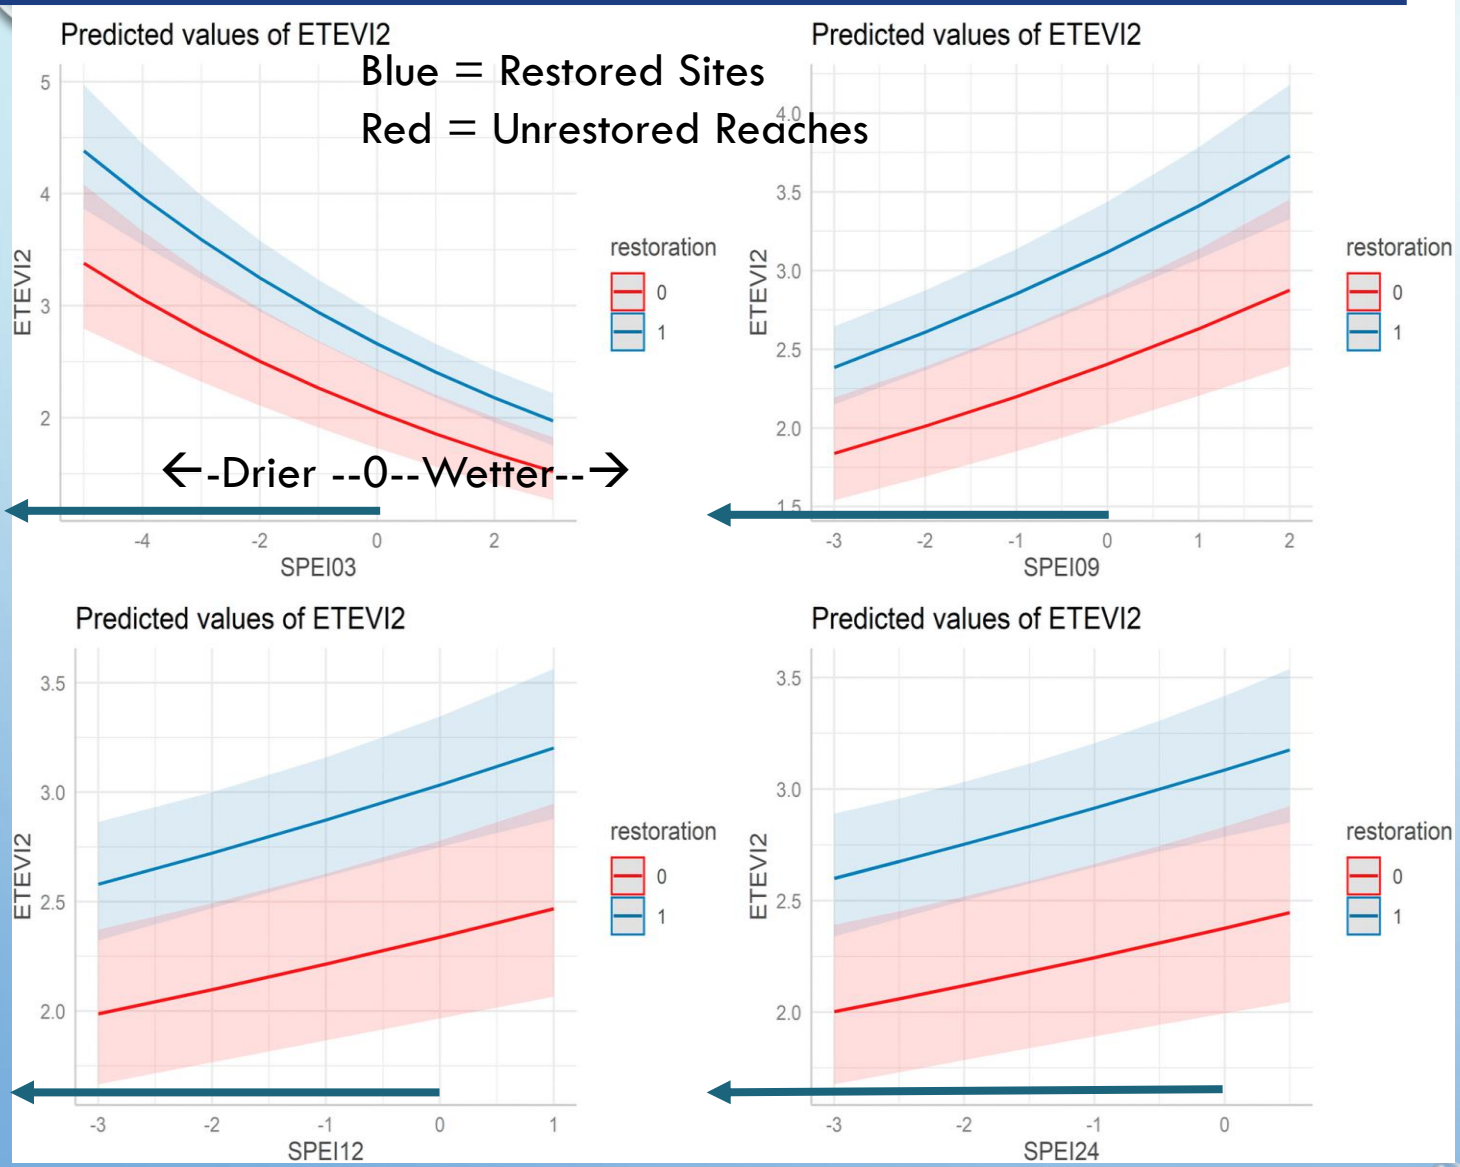
Relationship between ET and SPEI

Even though drought has an impact on restored (blue shaded) and unrestored reaches (red shaded), the reduction of vegetation health and water use is more pronounced in unrestored reaches (red) with an increase in drought severity (negative, see arrows) as shown by the predictive estimates.

Our results from ET(EVI2):SPEI indicate that drought indices with a time scale of 9-, 12- and 24-months are better suited in explaining the effect of drought on riparian water use because they are positive.

Only the ET(EVI2):SPEI03 relationship showed declines.
