# Hydrologic Investigation of the upper and middle Verde Watersheds

Kyle Blasch, John Hoffmann, Jeannie Bryson, USGS  
Leslie Graser, ADWR

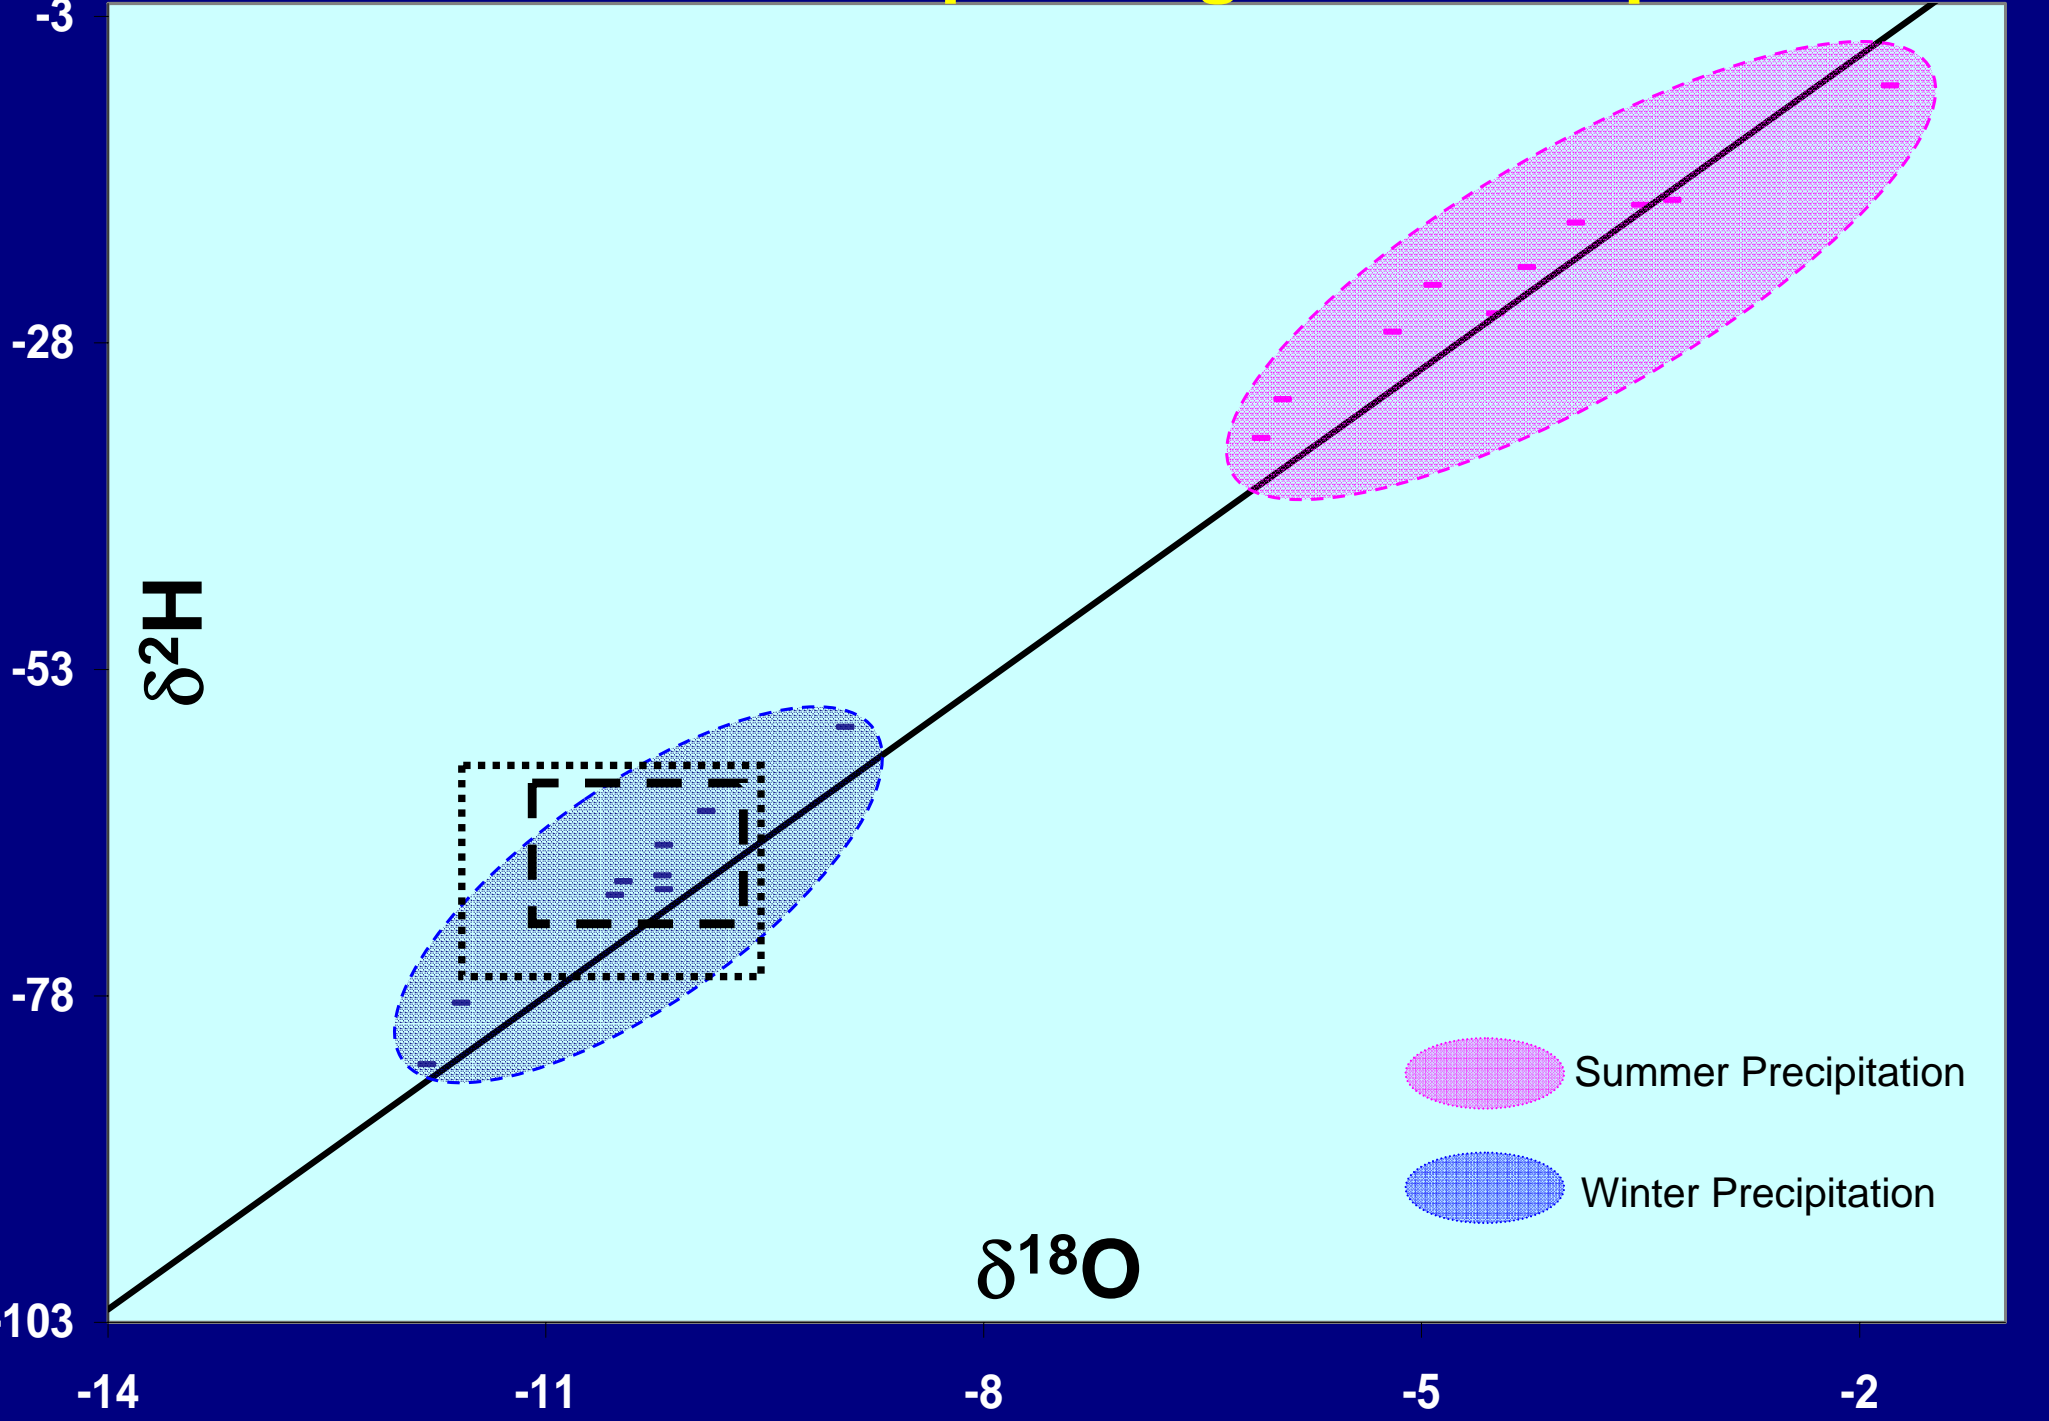
# Seasonal Stable Isotope Ranges in Precipitation

$\delta^2\text{H}$

$\delta^{18}\text{O}$

- Summer Precipitation
- Winter Precipitation
