ARROYO

Vol. 6 No. 2

Land Subsidence, Earth Fissures Change Arizona's Landscape

by Joe Gelt

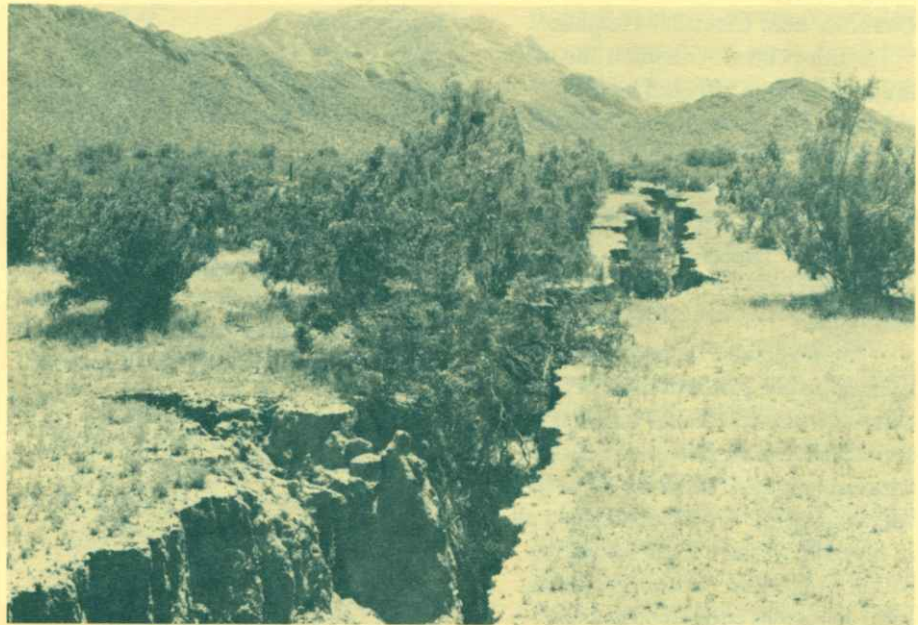
The above fissure is about one mile long and up to three feet wide and ten feet deep. It is about half a mile from the CAP aqueduct. The Picacho Mountains are in the background. (Photo: Steven Slaff, Arizona Geological Survey.)
